NAVAL POSTGRADUATE SCHOOL MONTEREY, CALIFORNIA

FAULT ASSESSMENT OF A DIESEL ENGINE USING VIBRATION MEASUREMENTS AND ADVANCED SIGNAL PROCESSING

Robert A. Armstrong

December 1996

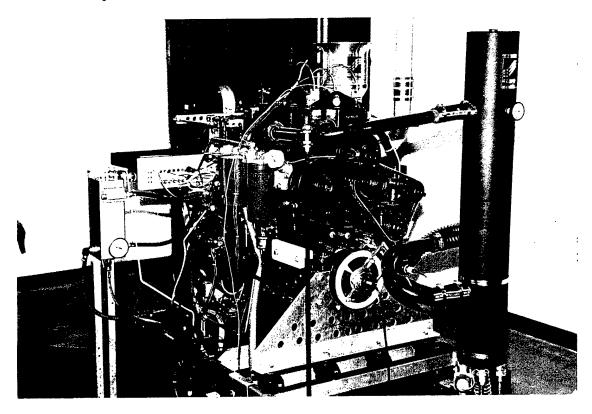
The engine setup for this laboratory is a Detroit Diesel 3 cylinder 53 series shown in Figure 3.1. The engine characteristics are listed in Table 3.1. This particular engine, serial #3D-68137 was manufactured in March 1970. It was used in a US Army 1-1/4 Ton Cargo Truck commonly called a "Gamma Goat". These trucks were phased out and 2 surplus engines were acquired in 1985. The paperwork with the engines indicated that they had been overhauled and were ready for use. During construction of the test cell several small problems were discovered and repaired. The problems ranged from a

Figure 3.1 Detroit Diesel 3-53 Test Engine

missing thermostat to the wrong type of fuel pump installed on the engine. Appendix A contains a list of all the mechanical problems encountered and the corrective actions taken.

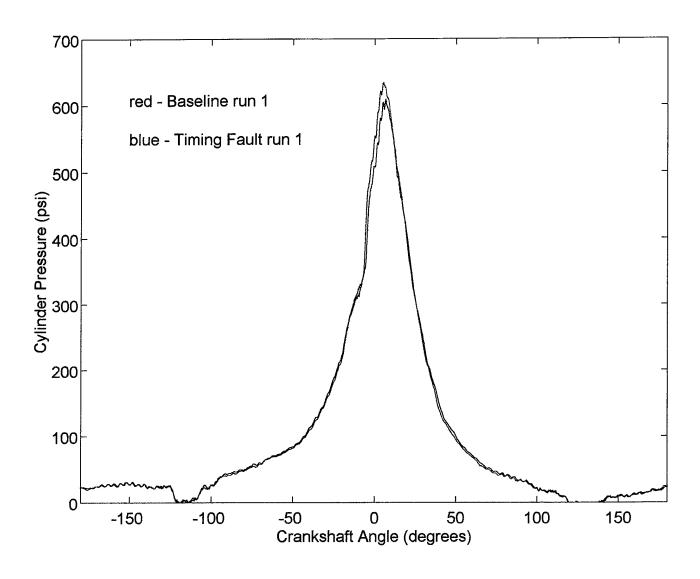
The data for the #1 cylinder pressure are plotted in Figure 4.1 and Figure 4.2. Figure 4.1 shows the complete engine cycle for one baseline data set and one timing fault data set. The bottom axis is the crankshaft angle from -180° to +180°. Several engine events are clearly distinguishable. Starting from the left, the intake ports and the exhaust valve are both open. The initial pressure level is due to the air intake blower forcing air through the cylinder. At -120° the intake ports are closed off by the movement of the piston and the pressure in the cylinder drops to atmospheric pressure. At -110° the exhaust valves close and the pressure begins to rise. The pressure peaks just after TDC. The baseline curve has a higher peak pressure than the timing fault curve, as expected. The pressure curves then fall as the piston moves down in the cylinder. At +110° the exhaust valves open and the pressure drops to atmospheric pressure. The intake ports open at +140° and air is again forced through the cylinder by the blower.

Figure 4.1 Cylinder pressure data plot for the complete revolution

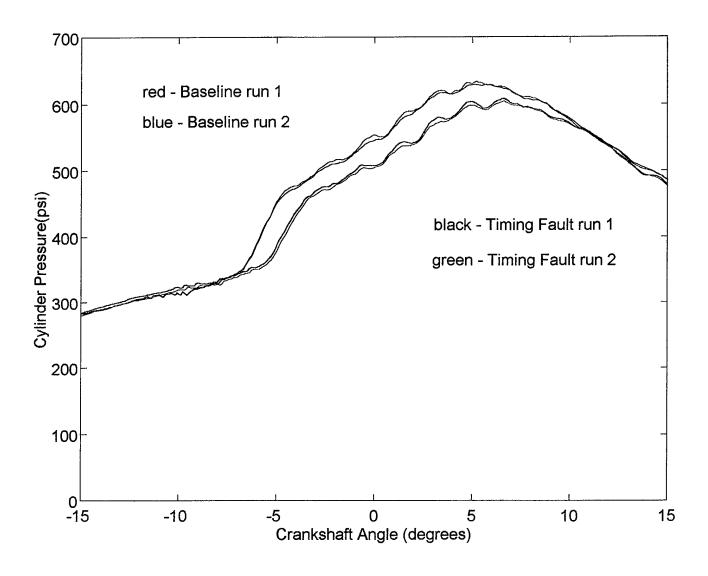
In Figure 4.2 two sets of baseline data and two sets of timing fault data are plotted. The bottom axis is adjusted to display the firing of the first cylinder. The four curves are nearly identical until the fuel injection occurs. The pressure rise associated with combustion is clearly visible. There is a 2° difference in the start of combustion between the baseline curves and the timing fault curves. The peak pressure point for the timing fault curves has shifted to the right and is 25. psi lower.

Figure 4.2 Cylinder pressure detailed plot

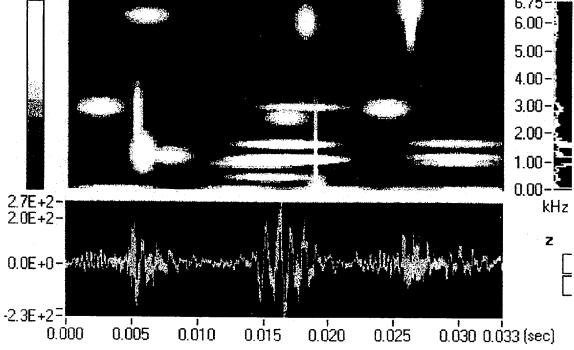
Figure 4.14 Adaptive Spectrogram of the engine timing fault condition vibration signal

Directly comparing the ASD of the baseline and fault condition signals, there is one feature which is clearly different. Figure 4.14 shows a broadband of energy at 0.018 seconds ranging from 0 to 3.5 khz. This feature does not occur in the baseline Figure 4.13. This broadband of energy could be the signature of a change in the combustion process due to the timing shift. This same broadband "scar" was found in all four of the data runs with the timing fault and did not appear in any of the four baseline data runs.
